Mid-Aug – Mid-Sep 2023 Accident Report and Pilot Deviation Summary – Jim Timm & Craig Tompkins

The following are the reports of aviation accidents, and incidents that have occurred in Arizona from mid-July through mid-August. We hope to use the following detailed accident information to develop safety programs, briefings, and posters/flyers that would help pilots learn from the mistakes being made by others and be able to take the necessary action to prevent them from having similar occurrences.

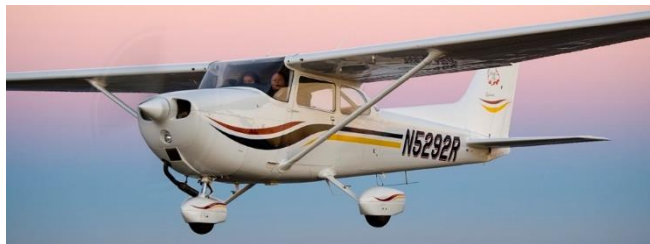
BIRD STRIKE

The Cessna 172 sustained a bird strike during the crosswind leg of a touch and go landing on RWY 21L at PRC. The bird, presumed to be a crow, resulted in a large 3-inch by 12-inch dent on the leading edge of the right wing.

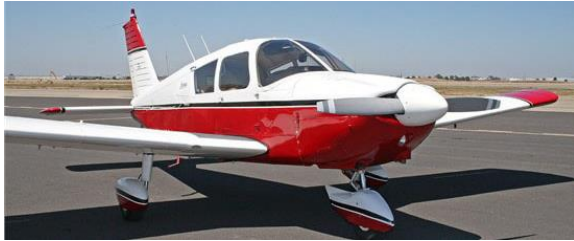
RUNWAY EXCURSION

The Piper landed on Runway 22R, and the aircraft went off the departure end, and into the grass. ARFF, and airport Operations responded to the aircraft, and ARFF reported there was no damage to the aircraft and there were no pilot medical issues. The aircraft was returned to the RWY 22R overrun pavement, and the aircraft requested to taxi to the Echo Ramp, which

was accomplished satisfactorily. A runway inspection was made, and there was no damage or FOD on Runway 22R, and it was made available for service.

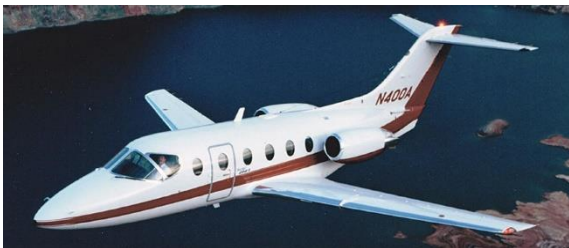
CRACKED WINDSHIELD

The Beech Hawker Jet took off from Mesa Falcon Field (FFZ) for Twin Falls, Idaho (TWF), and then diverted to Phoenix (PHX), declaring an emergency due to a cracked windshield. The aircraft made a safe landing at PHX without further incident.

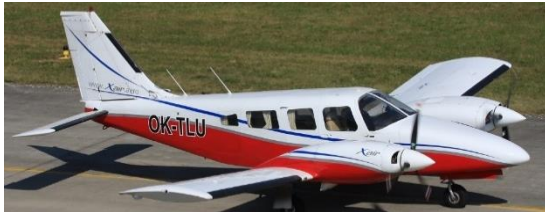
GEAR UP LANDING

The FAA reported that the Seneca II took off from Mesa, Falcon Field (FFZ) with a destination of Coolidge Municipal Airport (P08). The airplane landed gear up at Coolidge, lost control, and struck a runway sign with a wing, and was substantially damaged.

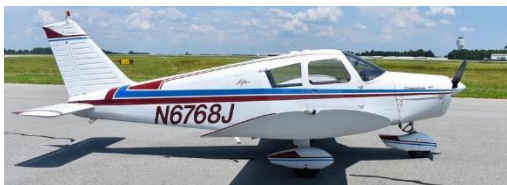
DENSITY ALTITUDE

The aircraft had departed Mesa Falcon Field (FFZ) with an ultimate destination of Grand Canyon-National Park Airport (GCN) and had stopped at Prescott Regional airport to re-fuel before continuing to Grand Canyon Airport. The NTSB stated the airplane took off from Prescott but was unable to climb, and the pilot attempted to make an off-airport landing on a road. The tail hit a tree during the landing attempt. While none of the occupants were seriously injured, the airplane was damaged substantially.

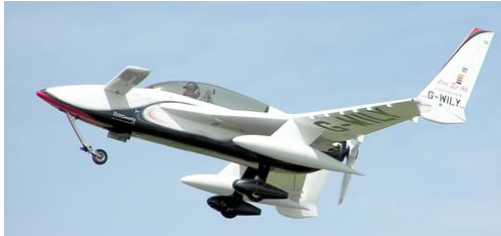
NOSE GEAR COLLAPSED

The Long-EZ departed Livermore California, and while landing at its destination, Bullhead-Laughlin Airport, the Nose Gear collapsed. The pilot lost control, and the airplane struck a sign, and some runway lights.

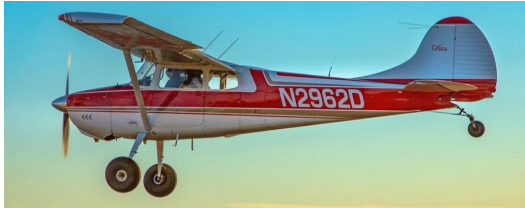
LOSS OF CONTROL LANDING

The Cessna landed on RWY 25R, and began to maneuver from side to side, and then came to rest nose down on the runway, incurring a prop strike. The extent of damage was undefined.

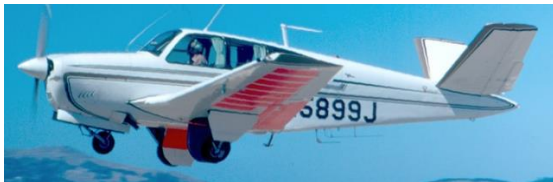
GEAR UP LANDING

The Beech Bonanza departed Ryan Field (RYN), and during the landing at its destination, Marana Regional Airport, the Bonanza made a gear up landing on Runway 12. All the damage was confined to the aircraft.

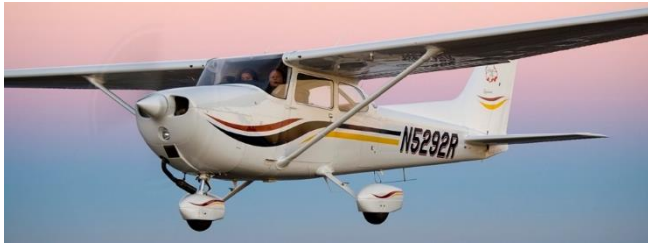
LOSS OF CONTROL LANDING

The solo Student Pilot was cleared to land on RWY 12C, however, after touching down the aircraft went off the side of the runway into the grass. Ground Control activated the Crash Phone, and the Emergency Response personnel responded. The ARFF team declared the aircraft was fire safe, and the aircraft was towed back to

the ramp. No injuries or aircraft/airport property damage was reported.

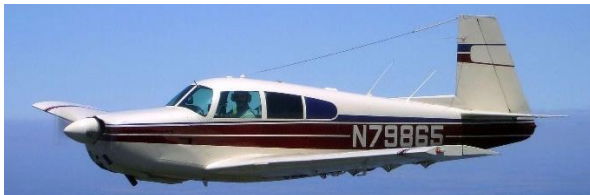
LANDING GEAR COLLAPSED

When the Mooney landed at Marana, the landing gear collapsed during the roll out. The extent of the damage was unreported.

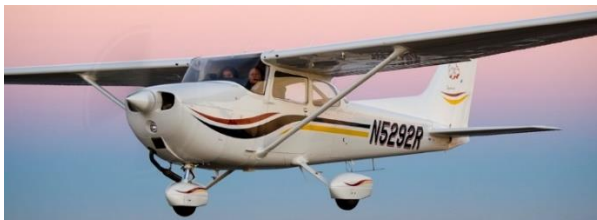
IN FLIGHT ENGINE FAILURE

The Cessna Skyhawk had departed Saint George Municipal Airport, in Utah (SGU), and had a planned destination of Mesa Falcon Field (FFZ). The airplane made a forced landing on the southbound lane of Interstate highway I-17 near Black Canyon City following a loss of engine power. Using the Guard

Frequency, the pilot attempted to communicate with ATC but was unsuccessful. He was able to communicate with several other aircraft who attempted to provide assistance.

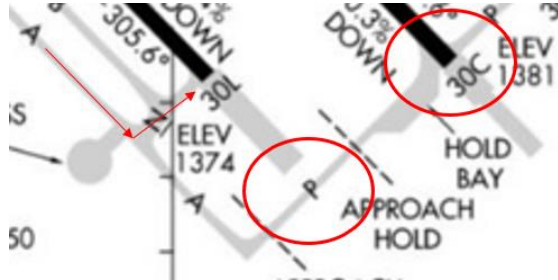
8/9, Failure to Follow Taxi Instructions, Pilot Certificate UNK, (Canada), Williams Gateway Airport (IWA)

The A-4 Skyhawk Fighter entered Taxiway PAPA without a Clearance. The aircraft was issued the taxi instructions to RWY 30L via ALPHA & NOVEMBER. Ground Control observed the aircraft passing Taxiway NOVEMBER and tried to reach out to the pilot(s), but he or she didn't reply. Both local controllers tried to reach out to the pilot(s) but couldn't get a reply. Ground Control reattempted to establish contact, and the aircraft replied

as they made the turn off of Alpha, and onto Taxiway PAPA. Ground Control told them to hold position, and then reassigned them to RWY 30C & switched them to the tower frequency.

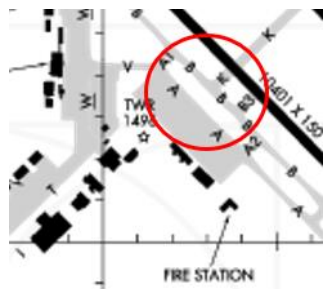
8/9, Entering a Movement Area Without Authorization, Tug Driver – No Pilot Rating Required, Williams Gateway Airport (IWA)

The Aircraft Tug entered taxiway Alpha abeam taxiway Kilo without establishing communication with ATC to obtain a clearance into the movement area.

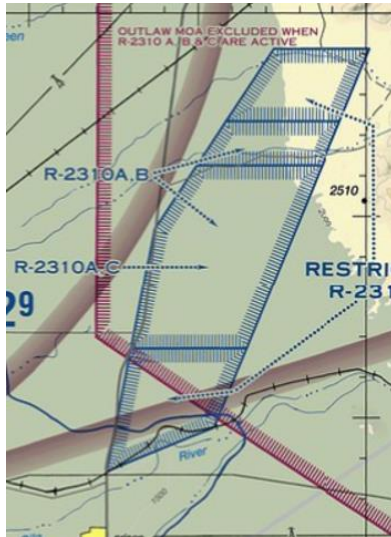
8/10, Entering a Restricted Area Without Authorization, Private Pilot (Texas), Albuquerque Center (ZAB)

The Mooney was VFR at 4,600 feet and an Albuquerque Controller observed that the Mooney was inside of restricted area R2310, which was active at 10,000 feet and below. The pilot stated that he did not realize the airspace was active. A **Brasher** was issued.
