Accident Report & Pilot Deviation Summary

Jim Timm & Craig Tompkins

The following are the reports of aviation accidents, and incidents that have occurred in Arizona from mid-March thru mid-April. We hope to use the following detailed accident information to develop safety programs, briefings, and posters/flyers that would help pilots learn from the mistakes being made by others and be able to take the necessary action to prevent them from having similar occurrences.

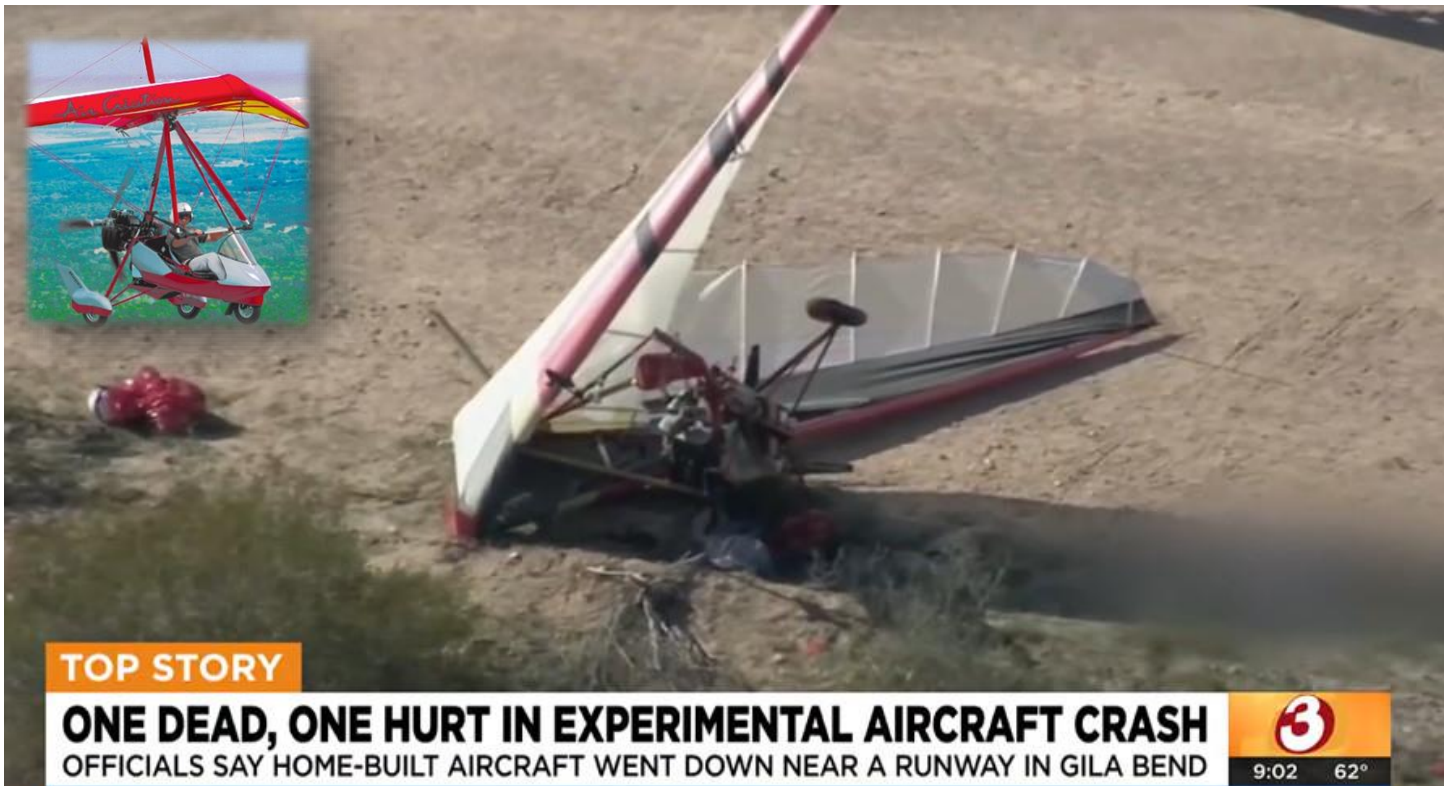
March 17, INFLIGHT LOSS OF CONTROL, Air Creation Twin, Gila Bend (E63), Private Pilot
Injuries: 1 Fatality, 1 Serious Injury

An experimental light-sport trike weight shift control Air Creation Twin was substantially damaged when it was involved in an accident near Gila Bend, Arizona. According to the passenger, who was seated in the front seat, intended on purchasing the aircraft, and was receiving flight instruction from the pilot. He reported that the morning of the accident, they had flown around the local area for about 45 minutes to increase his flight experience and understanding of the flight characteristics of a weight-shift control aircraft. The passenger stated that after the local flight, they returned to Gila Bend Municipal Airport (E63), Gila Bend, Arizona, and focused on takeoffs and landings on runway 04. Prior to operating in the airport traffic pattern, the pilot had briefed the passenger to maintain aircraft control during the approach to landing, and before the aircraft touched down, transfer control of the aircraft back to the pilot, who would abort the landing and initiate a go-around. During the second approach to landing, the passenger heard the pilot state, “my airplane” and relinquished the flight controls, as he heard the engine spool up to which he opined that the engines, “sounded strong.” The passenger stated that the aircraft turned to the right and overflowed the dirt area that paralleled the right side of runway 04. As the aircraft’s descent rate was arrested, it continued to drift to the right, over brush and vegetation. Subsequently, the aircraft turned left, toward the runway and the left wing struck a mesquite tree. The aircraft descended into the ground and came to rest on its right side, oriented on an easterly heading, about 2,634 ft from the approach end of runway 04, and about 158 ft southeast of the runway centerline.

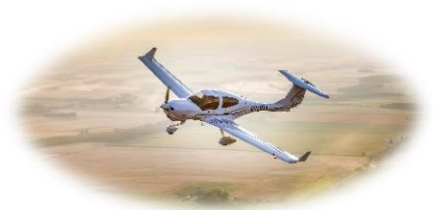
March 21, LOSS OF CONTROL TAKING OFF, Diamond DA40, Coolidge (P08), Private Pilot

The Diamond departed Phoenix-Mesa Gateway Airport for Coolidge to practice touch-and-go landings. During a takeoff the aircraft stalled, and came down hard on the landing gear resulting in substantial damage to the aircraft

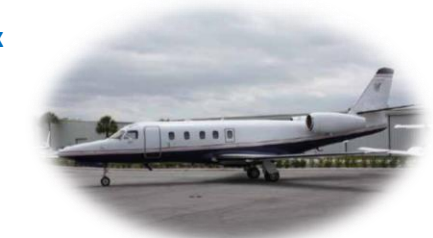
March 28, LOSS OF CONTROL DURING TAKE OFF, IAI 1125 Astra SPX, Phoenix Sky Harbor (PHX), No Pilot Information Available

An IAI 1125 Astra SPX Private jet overran runway 25L at Phoenix Sky Harbor Airport after an aborted takeoff and sustained minor damage.

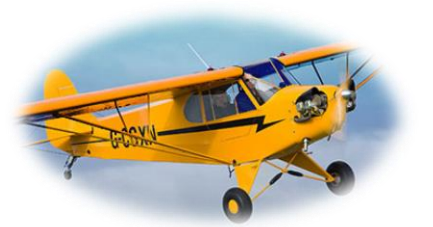
March 28, LOSS OF CONTROL LANDING, American Legend LA18 Super Legend, Phoenix Deer Valley (DVT), No Pilot Information Available

The aircraft ground looped on landing. The left wing struck the runway, and there was substantial damage.
