## Mid-April – Mid-May 2024

# Accident Report & Pilot Deviation Summary

Jim Timm & Craig Tompkins

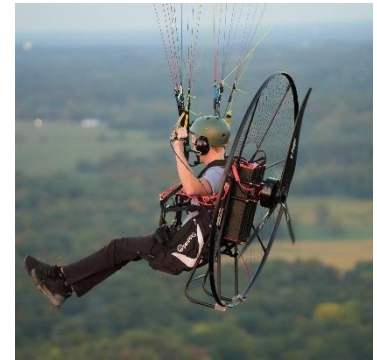
A “paramotor”, an Aircraft designation known as a Powered Parachute, sustained substantial

damage subsequent to an impact with terrain during an apparent landing attempt northwest of Ak-Chin Regional Airport (A39).

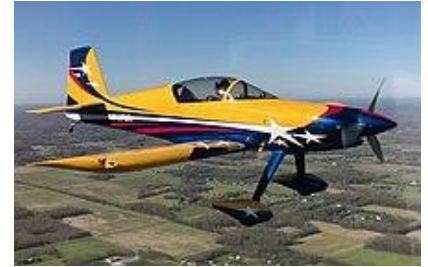
The aircraft had departed from Glendale Airport, and upon landing at Payson the aircraft encountered a cross wind, and the aircraft bounced, and drifted to the right. The right wingtip contacted the ground, bending the right landing gear, and experienced a prop strike, damaging the engine mount. The NTSB assessed the damage to be substantial.

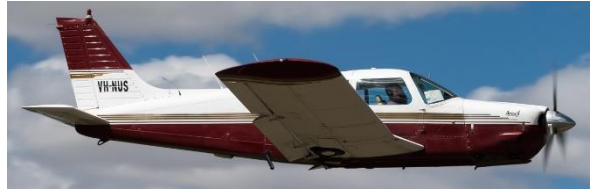
The Piper Arrow landed gear up at Tucson Ryan Field, and the NTSB assessed the damage to be minor.
